Condition Assessment

# Wilton Town Hall

Wilton, New Hampshire

July 2023

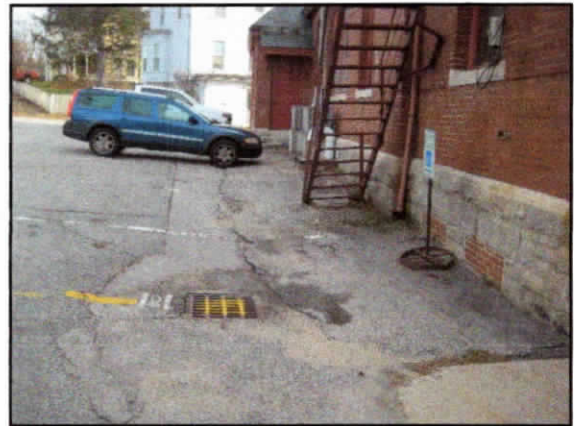
Photo 58 Parking outside Maple Street

- The site slopes down considerably from Maple Street on the east to Main Street on the west side. The only on-site parking is on the Maple Street side of the building. The asphalt paving in that parking area is cracked and uneven. There is no handicap access to the building from the Maple Street entrance, although there is one designated handicap parking spot (Photo 58).

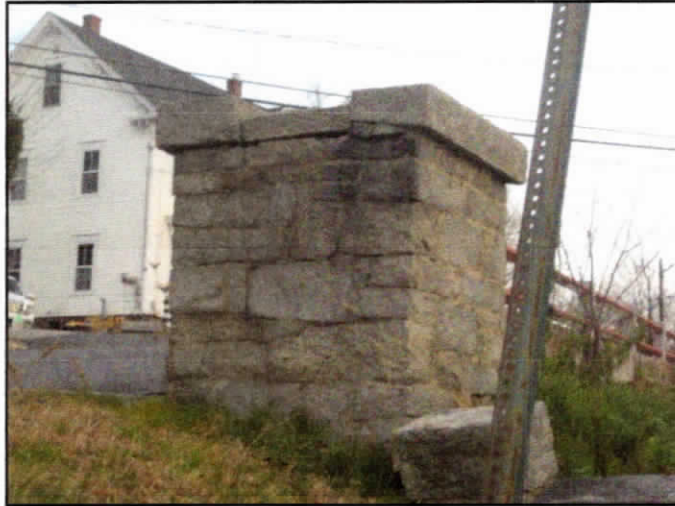
Photo 59

- The large blocks of the granite wall on the Main Street side of the Park have shifted some over the years, and some of the capstones need re-setting. There is a taller post comprised of multiple granite blocks where the two retaining walls meet that is missing some capstone pieces.

Missing capstones at granite post

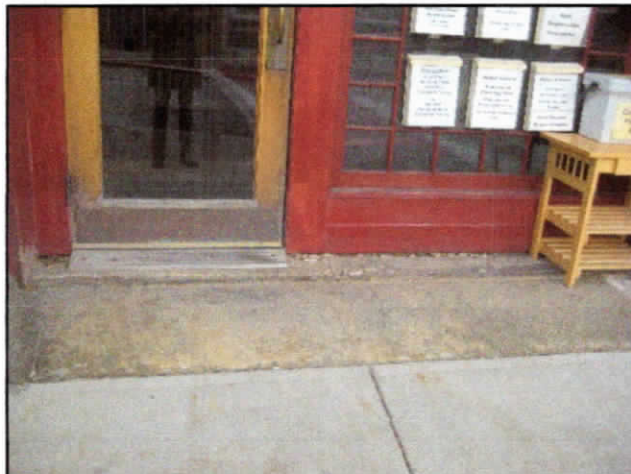
Photo 60

- The sidewalk that connects the two entrances on the Main Street side of the building is a combination of broom-finished concrete with real brick edging and stamped concrete in a brick pattern. The brick edging is broken in places. The stamped concrete is in good condition, but slightly chipped at the edges on the north and south ends.
- The sidewalk outside of the south Main Street entrance is pitched too steeply from the street to the face of Town Hall to allow for ease of access for a wheelchair. There is a granite threshold at that entry door that is somewhat uneven. There is an automatic door opener to alleviate that condition somewhat, but a better solution is needed there.

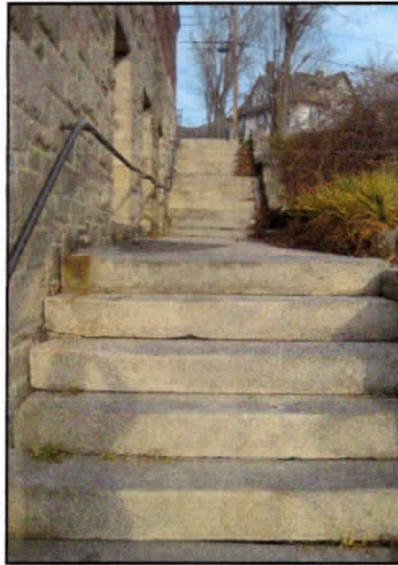
Photo 61

- There is a flight of granite steps adjacent to the south side of the building that traverses from Main Street up to Maple Street. The steps are uneven and somewhat worn by over a century's worth of foot traffic.

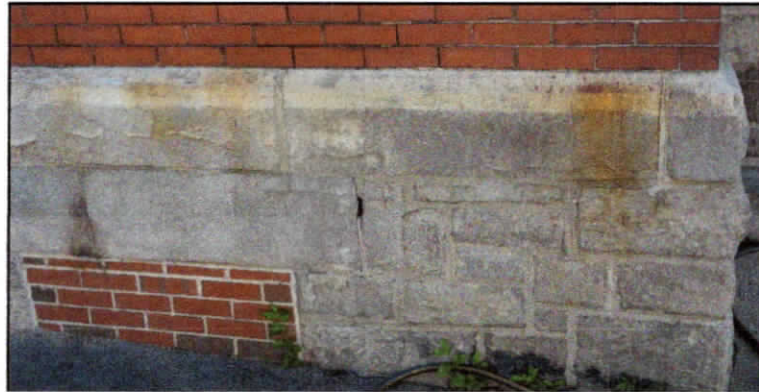
Photo 63

- The granite masonry at the base of the building is generally in good condition and needs only minor re-pointing. There is also a limited area of rust staining caused by the deterioration of the fire escape on east side.

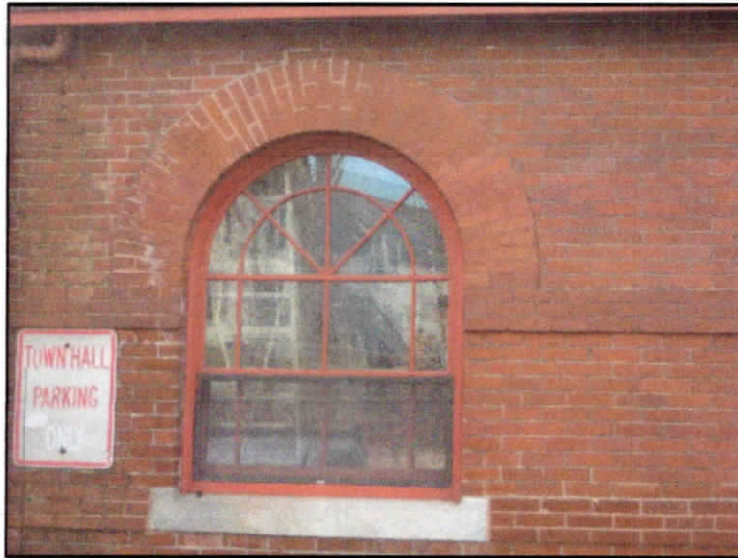
Photo 65

- The brick masonry is generally in good condition. However, over the years it has been re-pointed with badly mismatched mortar colors. The original red mortar can be seen in the arches over many of the windows, and in the sheltered recess of the Maple Street entrance. Varying shades of gray mortar have been used for re-pointing over the years, lending a bit of a patchwork effect to the once monochromatic red walls.

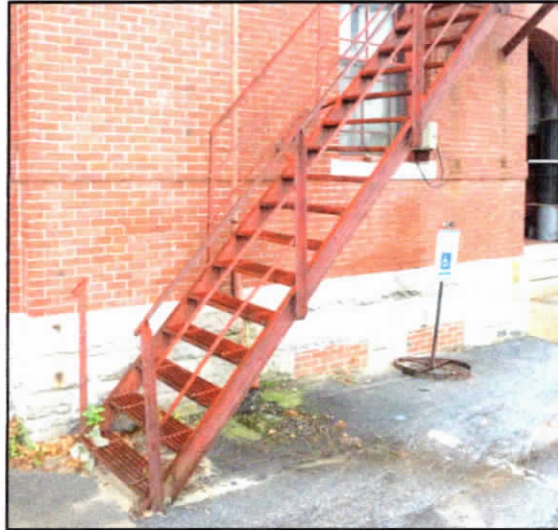
Photo 67

- The fire escape leading from the balcony on the east (Maple Street) façade is missing a portion of handrail at the bottom section and is in need of painting. (It should be noted that the theater balcony is not in use by the public at the time of this report.)

Fire escape is missing a portion of handrail

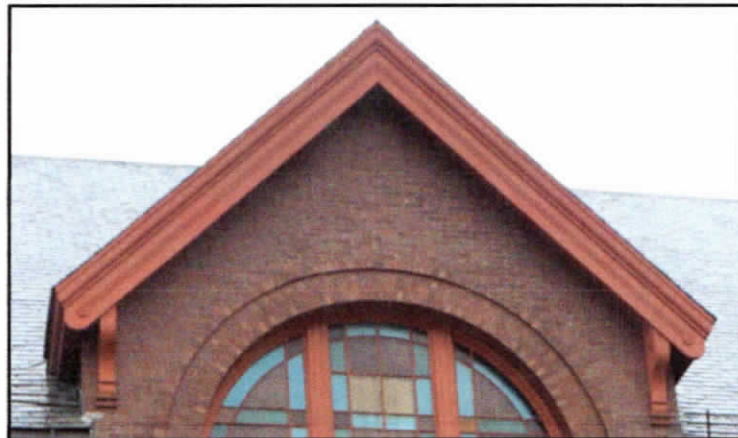
Photo 68

- The wood trim on rakes and eaves is in good condition.
- Wood shingle siding on the south gable wall is in good condition.
- The wood louvers and trim on the clocktower are in need of repair.

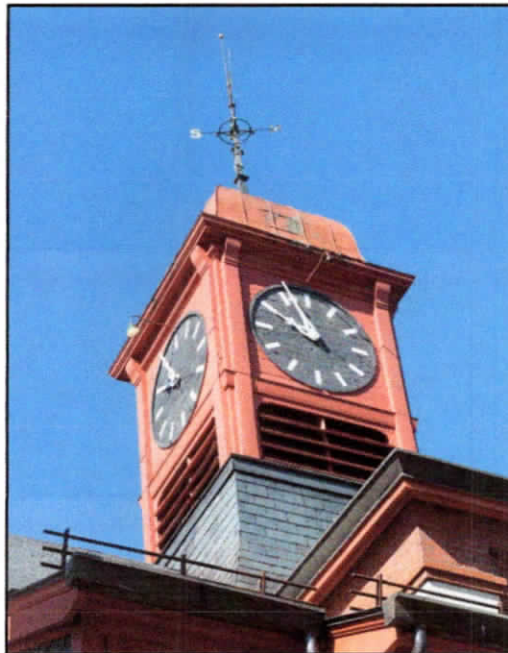
Photo 69

- The painted copper roof of the clocktower appears to be original. It has reached its serviceable life, is leaking and in need of replacement.

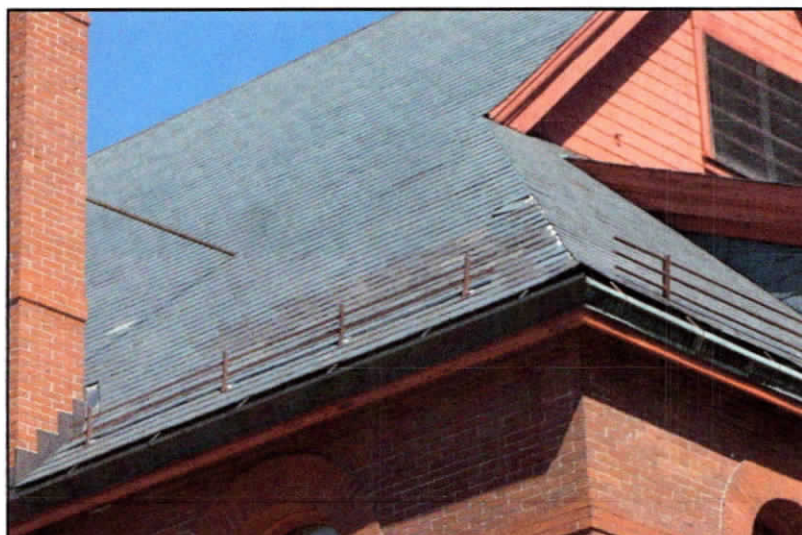
Photo 70

- Roughly 5 to 10 percent of the roof slates are broken or missing. Much of the damage is in areas where the snow guards cause snow and ice buildup.

Area of broken slates at southwest corner

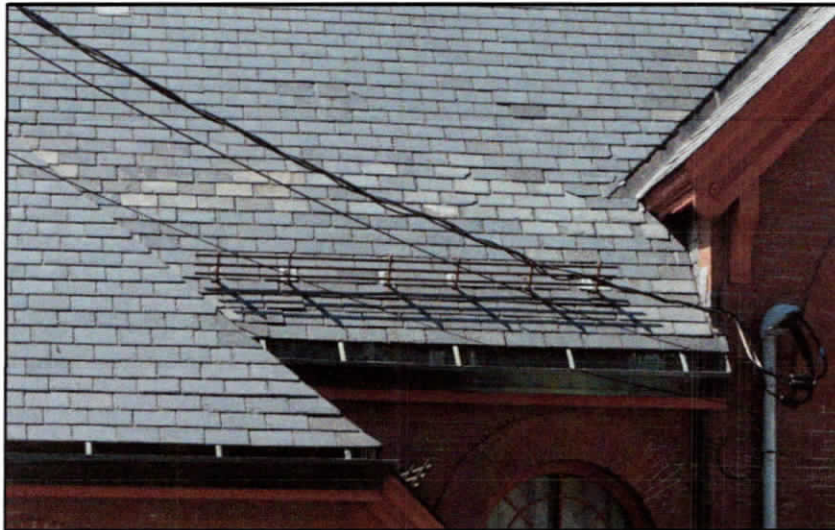
Photo 71  
Broken slates on Maple Street elevation

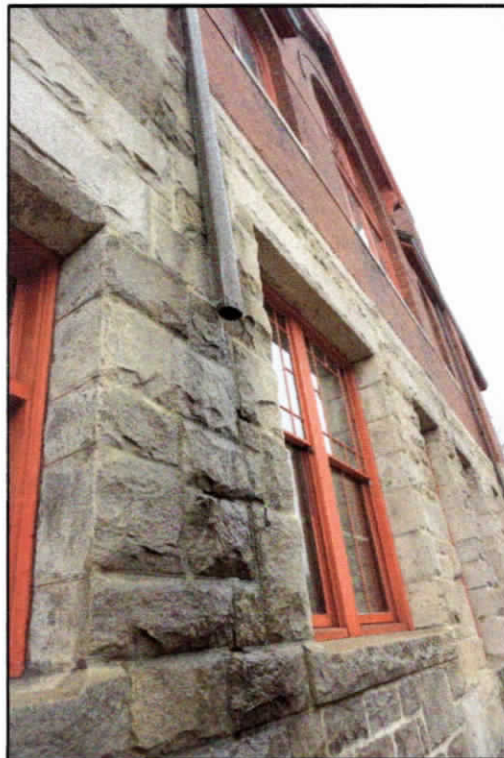
- Some of the copper flashing and gutters have been replaced or repaired in recent years. A number of the copper downspouts are missing their lower lengths or need to be redirected. This will tie into the site drainage work.

Photo 72  
Missing downspout on Main Street elevation

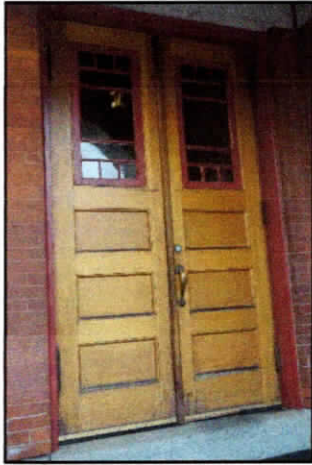
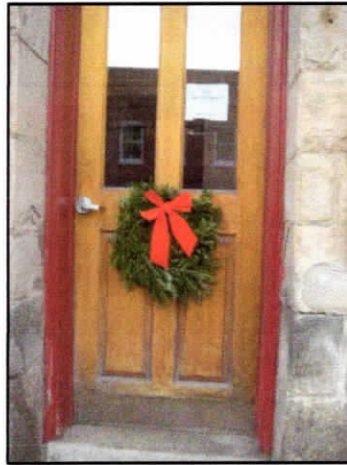
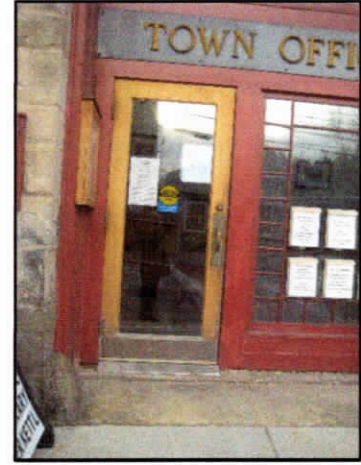
Photos 73-75

- The entry doors that access the theater from the Maple Street side are in good condition. The second egress door from the front of the theater to Maple Street is also in good condition (see Photo 17).
- The three entry doors on the Main Street side are all in need of refinishing (Photos 73-75).

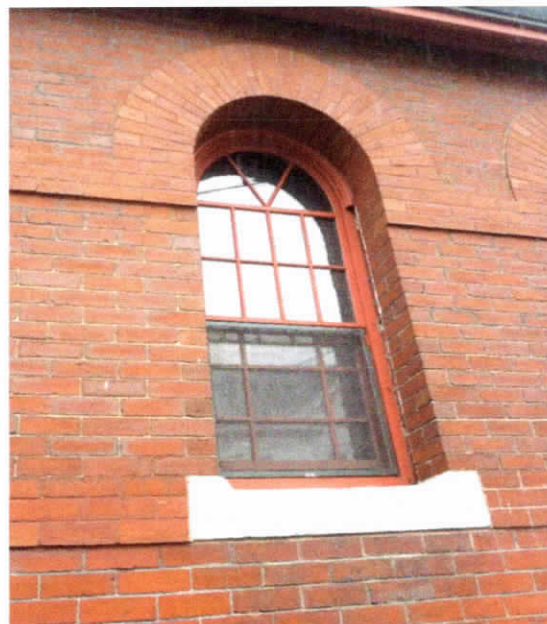
Photo 76

- The windows are generally in good condition. There is an arched window on the Maple Street elevation missing a side molding (Photo 76).

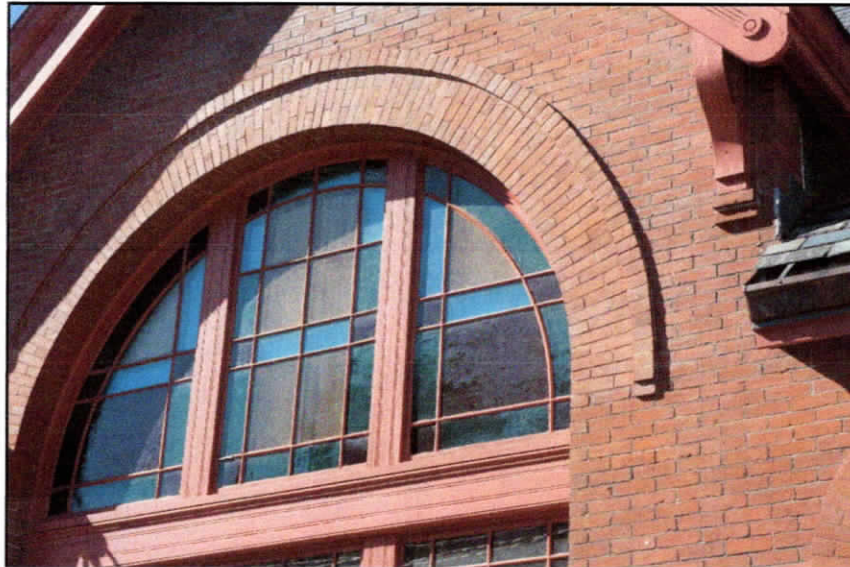
Photo 77

- The colored glass arch window on the west (Main Street) façade has a broken muntin.
- There is a broken pane in the colored glass arch window on the east (Maple Street) façade. There is also a damaged muntin in that window.

View of the arch window on the Maple Street side.  
Note the cracked pane of colored glass in the lower right.

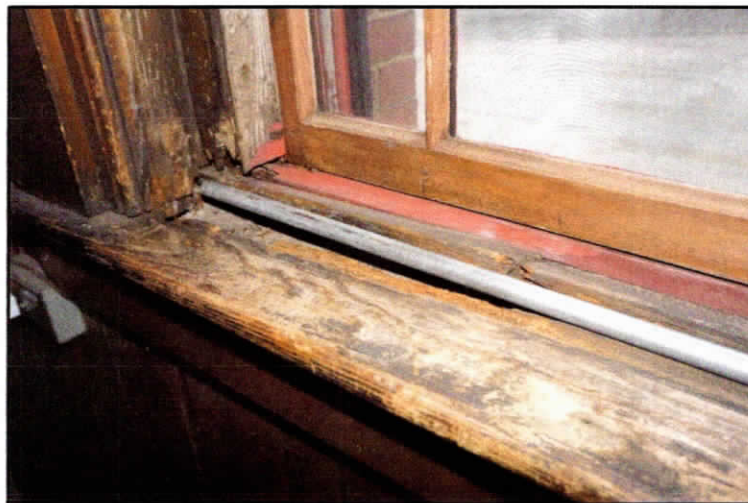
Photo 78

Deterioration of windows on this elevation is also evident inside the theater, behind the curtains that cover the windows (Photo 78).

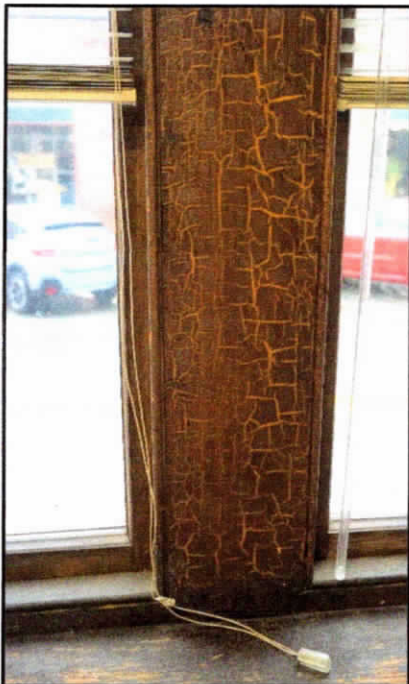
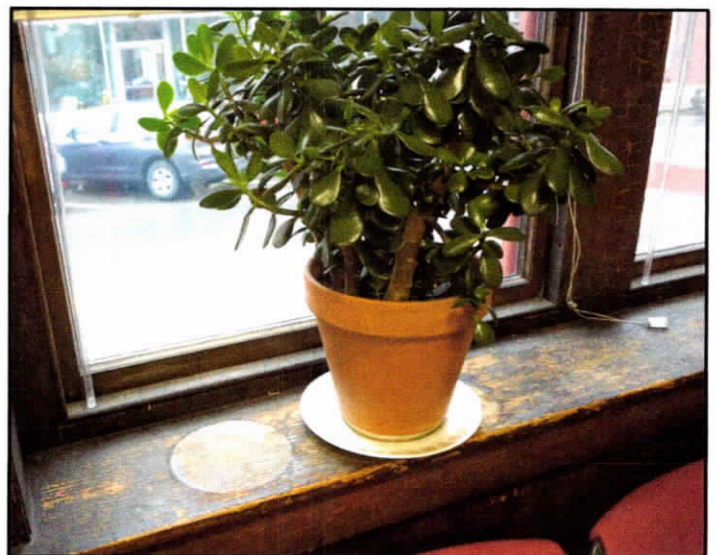
Photos 79 &amp; 80

- The maple flooring is in generally good condition, having only a few slight scratches.
- The walls have stained wood wainscoting on the south, west and north walls that is in good condition. The painted plaster above is in good condition. The east wall is entirely painted plaster in good condition.
- The finish on the woodwork surrounding the windows is alligatored at the jambs and heads and is very worn and the sills are water damaged.

**Damaged woodwork on west windows in Courtroom**

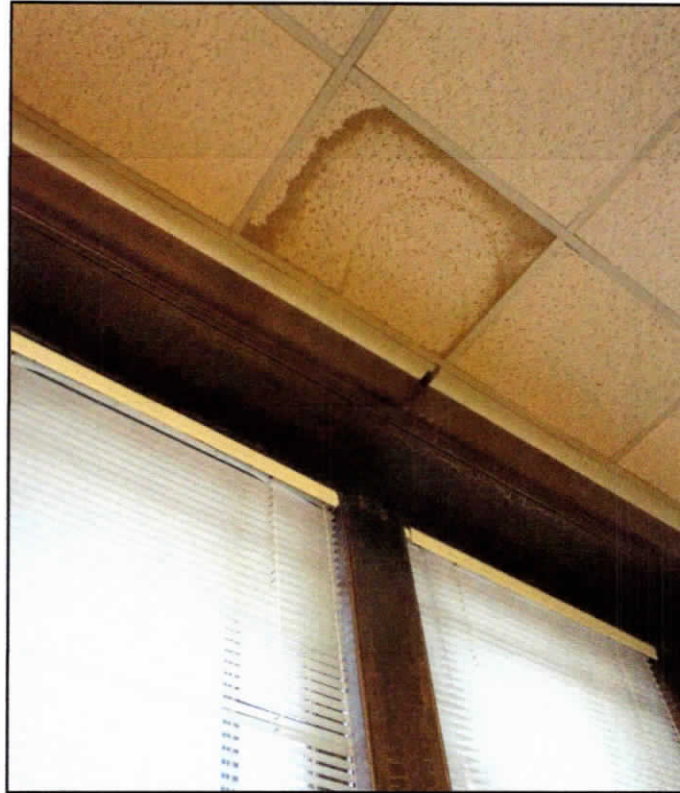
Photo 81

- The ceiling is a 2x4 suspended acoustical tile in generally fair to good condition. A few tiles are damaged or dislodged. A tile is damaged near the north wall where electrical penetrations were made for the emergency light. Some of the tiles adjacent to the west wall are water stained (Photo 81). The source of the water was likely from a radiator leak upstairs. The leak is no longer active.
- Light fixtures are 2x4 parabolic drop in fixtures in good condition.
- Heat in this space is steam delivered through Runtal – type baseboard units.

Water-stained ceiling tile on west wall of Courtroom

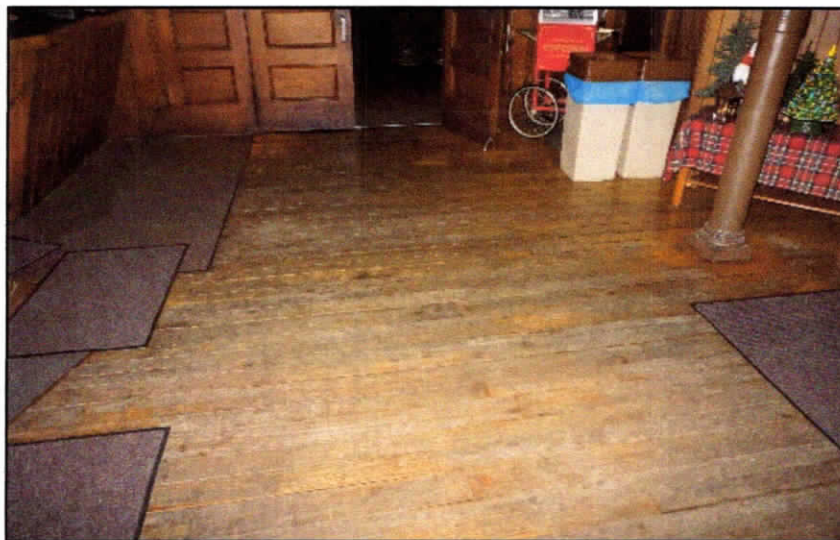
Photo 82

- The stained wood stair to the Upper Theater Lobby is well worn. The treads not only have a worn finish, but the wood is actually worn down from many years of foot traffic.
- The theater lobby flooring is wood in fair condition.

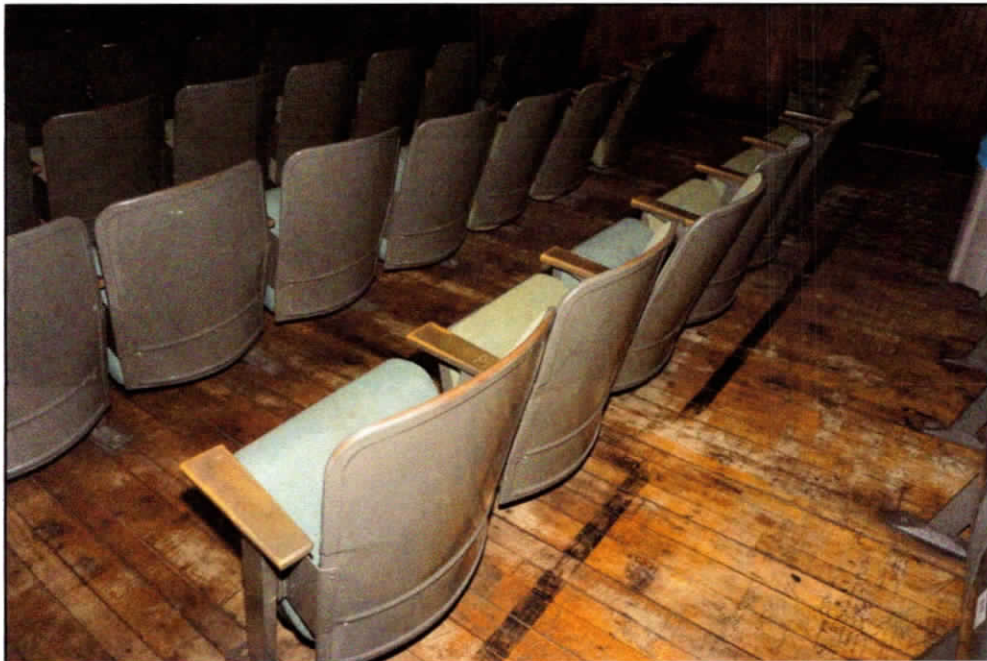
Photo 83

- The flooring below the seating is wood that is in fair to poor condition. The finish is quite worn.

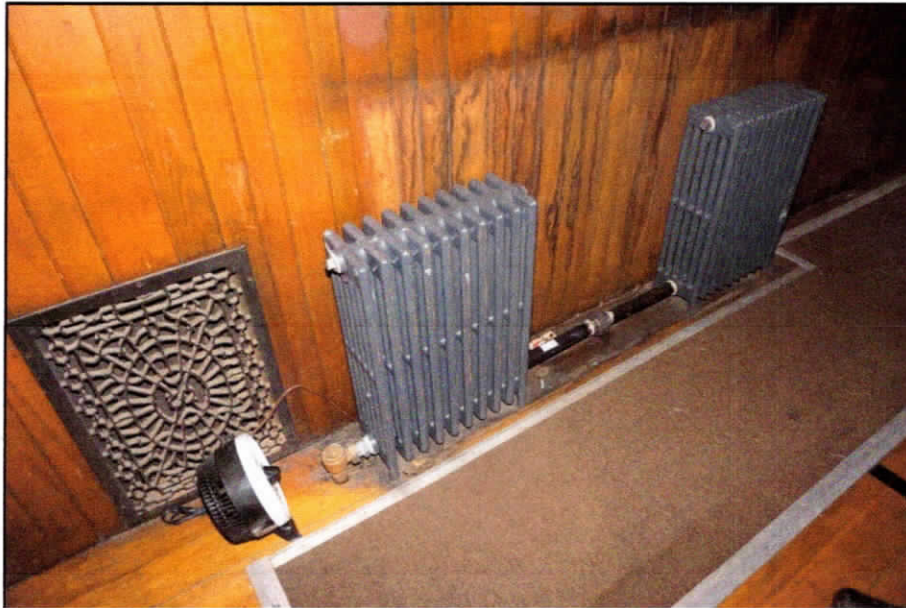
Photo 84

- The aisles are carpeted. The carpet is in fair condition.

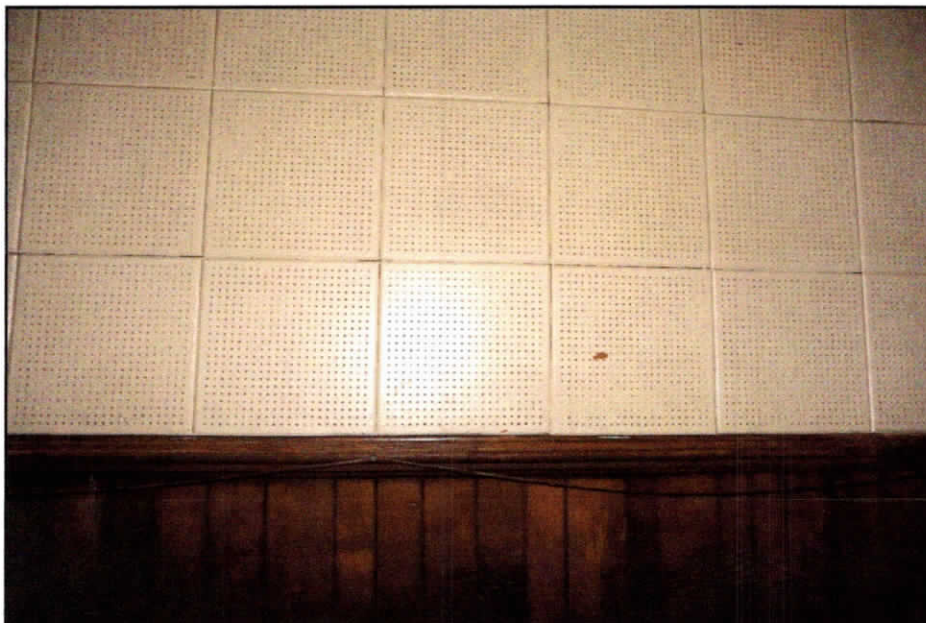
Photo 85

- Walls are painted plaster with wood wainscoting that is water damaged in multiple locations. Acoustic ceiling tiles have been added over the plaster portions of the walls.

Acoustic tiles cover the plaster walls

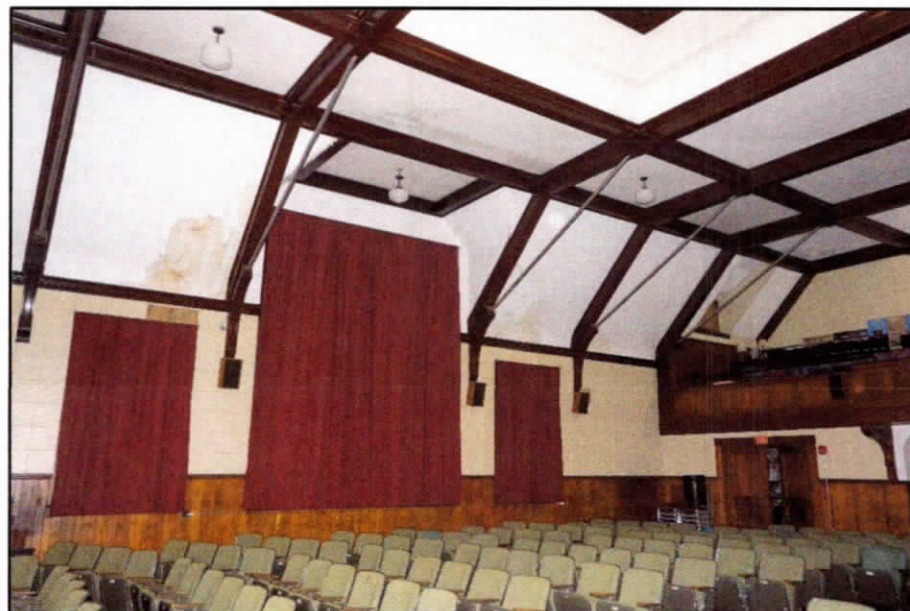
Photo 87

- Blackout curtains cover the windows in the theater.
- The ceiling is painted plaster with exposed timber & metal trusses. There are many water stains on the ceiling.
- There are schoolhouse style pendant light fixtures. Lighting levels are quite low. Only one light fixture is currently working in the theater.
