Condition Assessment

# Wilton Town Hall

Wilton, New Hampshire

July 2023

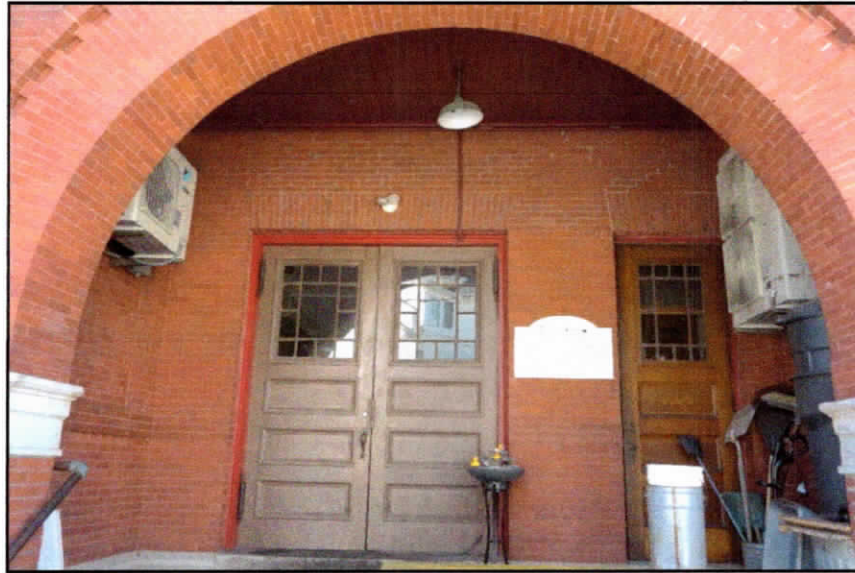
Photo 17  
Maple Street entrance

- The entry doors that access the theater from the Maple Street side are in good condition. The second egress door from the front of the theater to Maple Street is also in good condition (see Photo 17).
- The three entry doors on the Main Street side are all in need of refinishing (Photos 73-75).

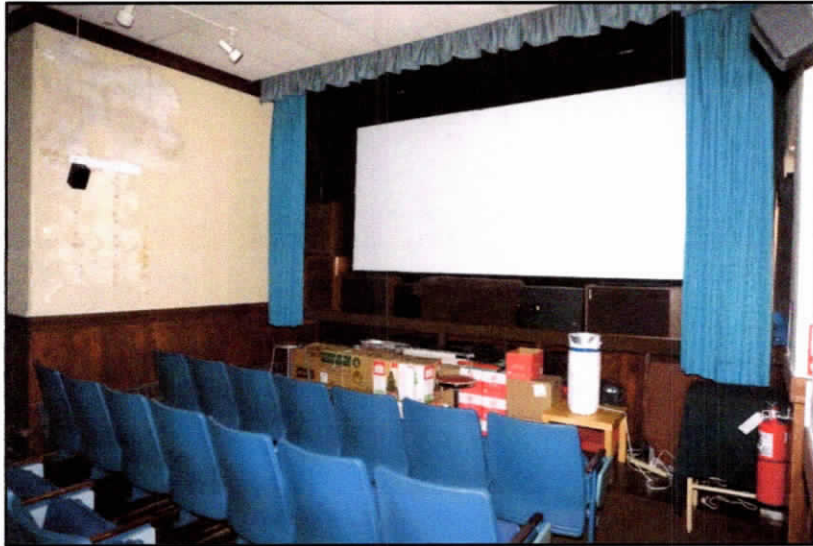
Photo 36  
“Screening Room”

In 1988, the former library space was converted into a small movie theater (“screening room”). The space retains original vertical wainscoting and plaster walls. The original ceiling is covered by acoustical tiles and the original plaster shows considerable water damage. Theater seats recycled from another location were installed.

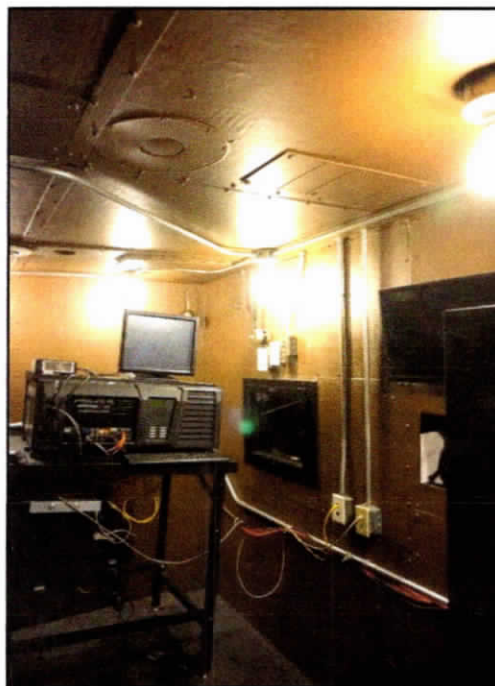
Photo 55  
Inside the Projection Room

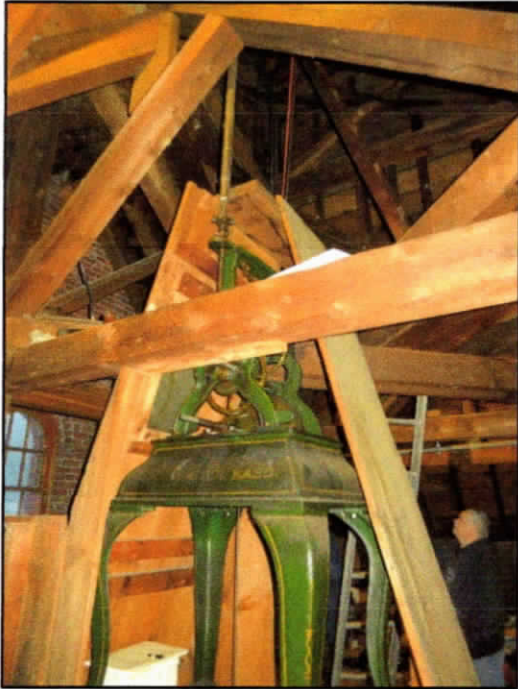
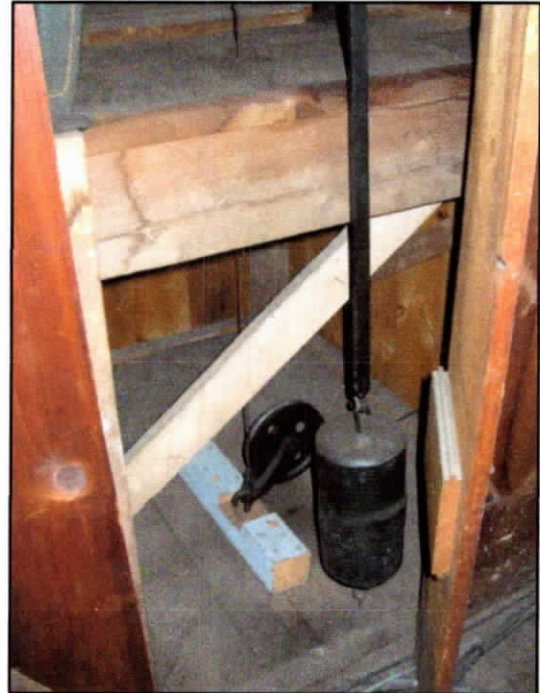
In the northeast corner of the balcony level, rough stairs lead up to the clocktower. The clock movement was manufactured by George Milton Stevens of Boston and is original to the building. Carved into a beam by the clock is the date “1884” and some initials. As the weight falls, it drives the clock’s mechanism. It is still operational today.

Photos 56 & 57  
Clock movement and weight

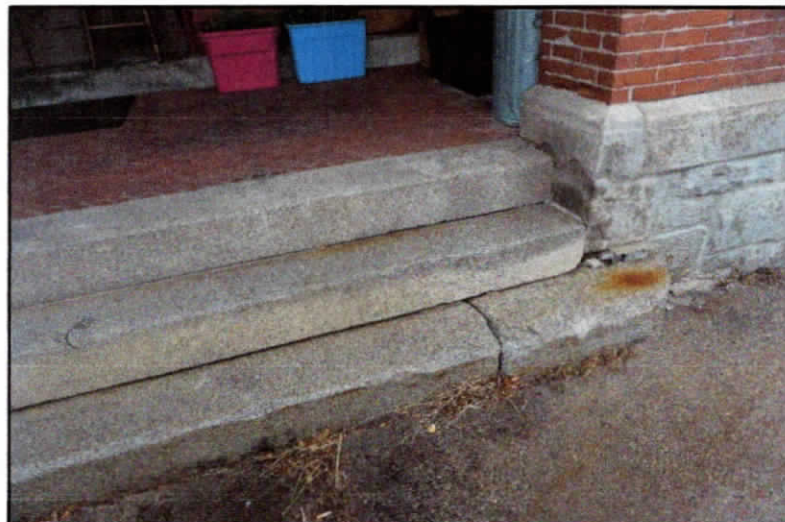
Photo 62

- A low rubble stone retaining wall along the south side of the stair is in need of repointing.
- The granite steps at both the main Maple Street entrance and the secondary egress at the south end of the Maple Street side need re-setting.

Steps at Maple Street entrance

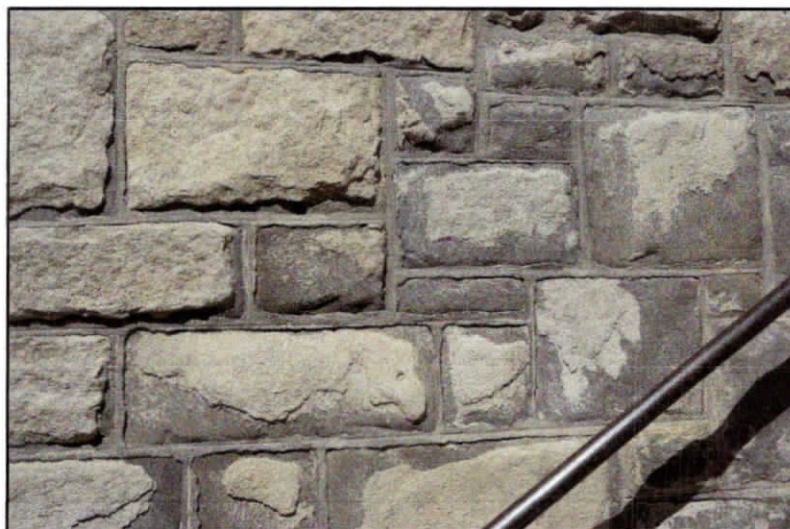
Photo 64

- There are remnants of some type of parging over the granite on the south and west walls. The parging material is very brittle and is flaking off in many locations. It is unclear when or why that application was done.

Remnants of parging that is flaking off of the granite masonry on south elevation

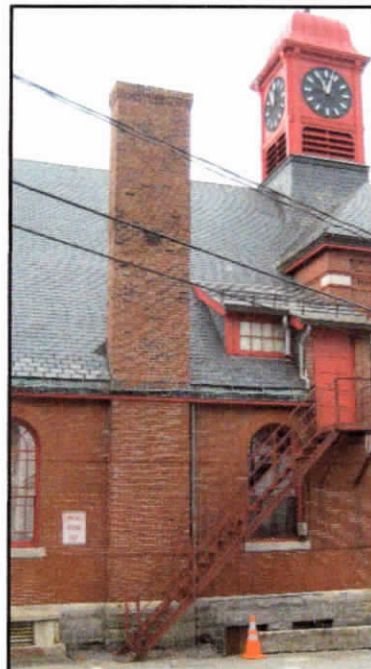
Photo 66

- The chimney on the Maple Street side of the building was re-built some years ago with both mismatched brick and mortar.

Reconstructed chimney on Maple St.

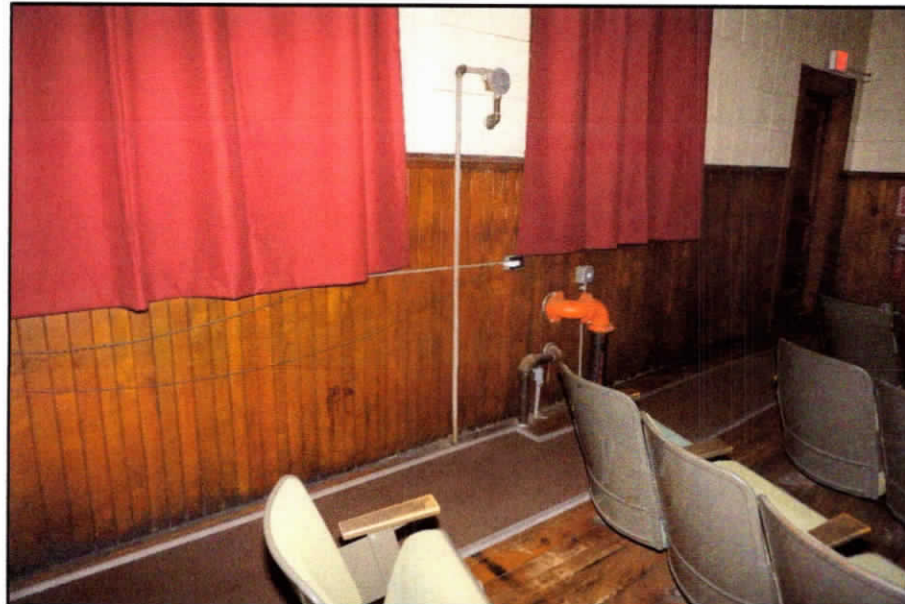
Photo 86

- Blackout curtains cover the windows in the theater.
- The ceiling is painted plaster with exposed timber & metal trusses. There are many water stains on the ceiling.
- There are schoolhouse style pendant light fixtures. Lighting levels are quite low. Only one light fixture is currently working in the theater.

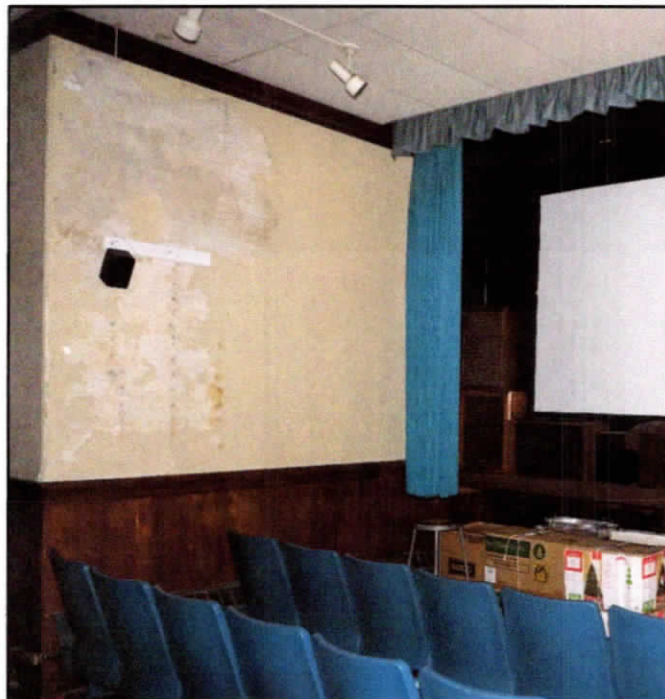
Photo 88

- Flooring is wood that is in fair condition. The finish is quite worn.
- Walls are painted plaster above wood wainscoting. The plaster is damaged in places.
- The ceiling is 2x4 suspended acoustical tile that is stained in some locations.
- The upholstered seating is in good condition.

Damaged plaster on north wall of Screening Room

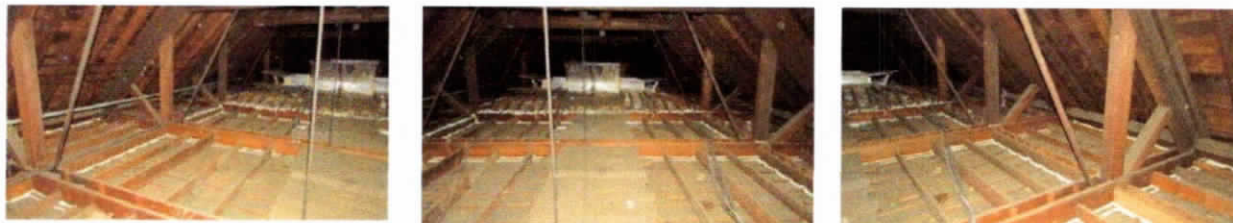
- The timber bents and structural members appear to be in good condition. The first set of photos (photo 89) shows the attic structure prior to the 2016 re-insulation project. The attic is now fully air sealed and insulated with 16 inches of blown cellulose (photo 90).

Photo 89  
Attic prior to insulation

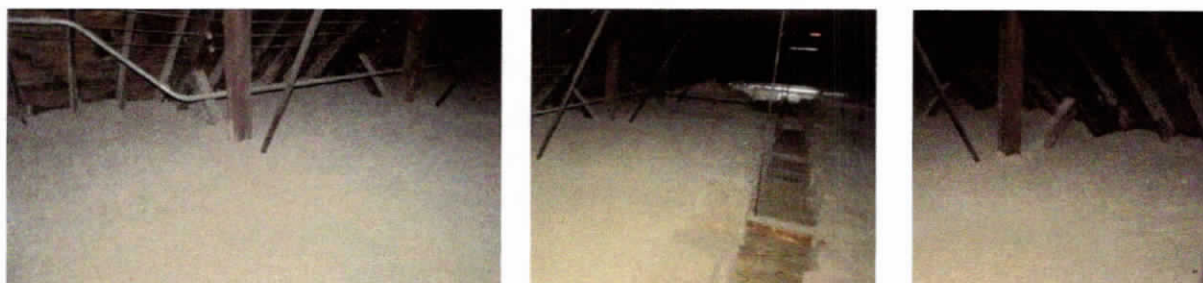
Photo 90  
Attic following installation of cellulose insulation
